WORKSHOP

Servicing the Smiths speedometer.

Three Litre cars - Wheel alignment

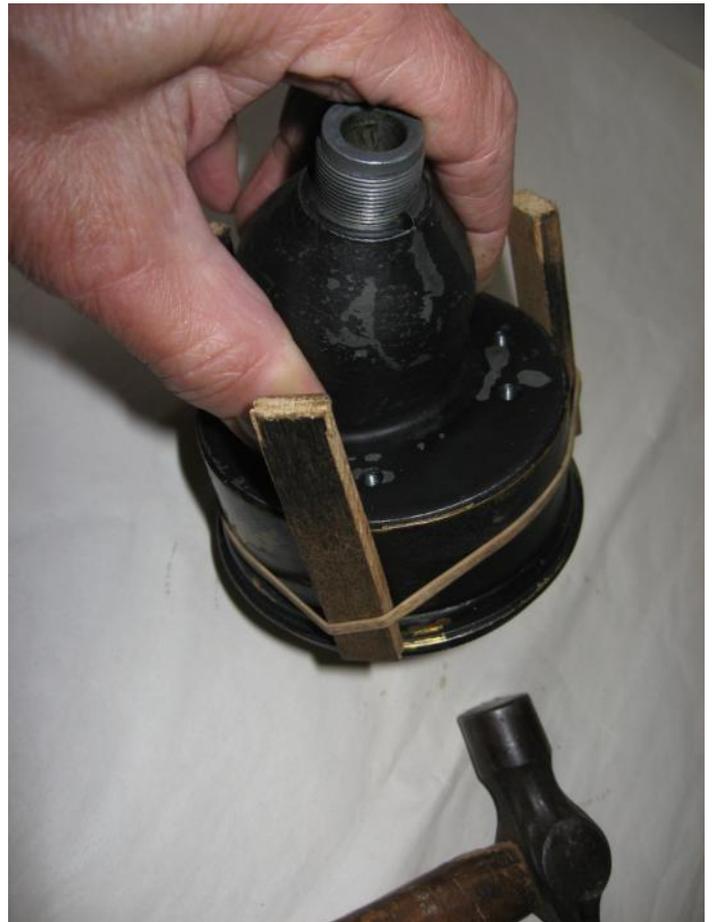
Separating the bezel from the body.

I found the following worked well for me. First remove any of the small retaining screws securing the housing to the body (often there are none left if someone has been here before you). Using three bits of 3-ply or similar, about 1/4" by 3", fit them around the body with ends lodged on the lip of the rim and hold in place with an elastic band (as photo). Grip the instrument upside down in one hand and tap the ends of the wood splints with a small hammer, moving round the circle.

With luck the housing will start to separate from the body and when it is about half way off it should be possible to remove it fully with gentle pressure. Be careful in the final disengagement because the glass and silver plated "nest" will also come away and will not appreciate the long drop onto to your concrete floor.

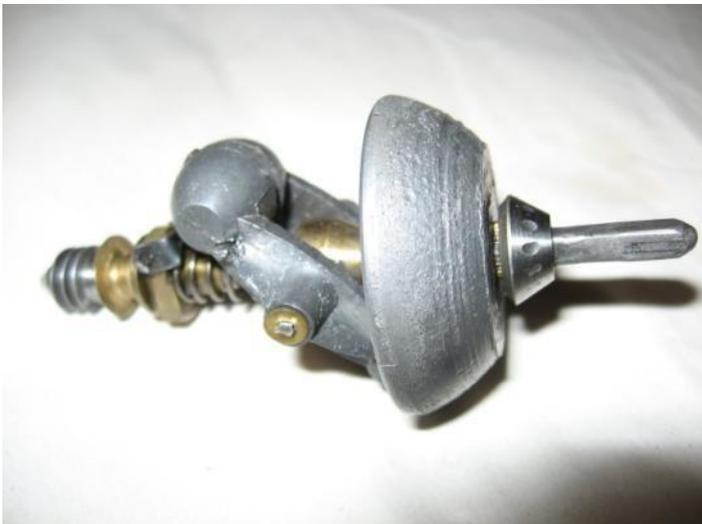
Close up of the drive spindle shows a badly pitted bearing cone (extreme right). This one is probably beyond salvage. Has any member experience of dismantling and refurbishing this pressed up assembly? The various speed ranges (60, 80, 100 etc) of the instruments are determined by the rate of the coil spring on the spindle.

The reason for the noise of the instrument was now evident; the upper cone on the drive spindle was badly pitted possibly through poor lubrication or lack of working clearance on assembly. I don't think removal and replacement of the cones is a simple matter and being unwilling to use force I settled for mounting the spindle in the lathe and dressing the cone with a Swiss file and emery to give a more presentable bearing surface. I would be keen to hear if anyone has more experience at this point. I limited other work on the instrument to gentle cleaning with white spirit and cotton buds to remove most of the grime, followed with sewing machine oil where it looked useful. I know of an architect who using Indian ink and squirrel hair brushes has repainted all the little numbers on all the little dials on the odometer, but he has a steady hand as a result of a virtuous and alcohol free life. Those of us who usually spill at least

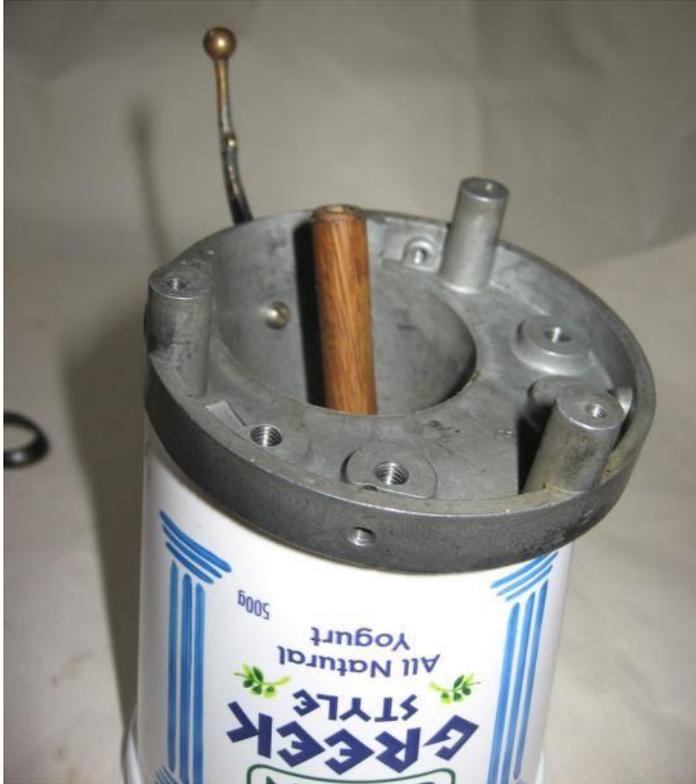
Repair of broken trip lever mount. The mild steel fulcrum is fixed to the outside top of the body.

some of our porridge should not attempt this. The remount of the trip lever was undertaken by fabricating a mild steel fulcrum to carry the brass trip lever. The remains of the mazac mounting were filed off and the body cleaned up with a file so that the brass housing is an easier fit on reassembly. The new mount is secured with two 2BA fastenings screwed into the body. The wall thickness is only about 1/8" which is not a lot of thread, but neither is there a lot of force on the fulcrum. if tempted to secure it using a nut inside the body be careful that there is clearance for the governor whirlygig which needs most of this space when in motion.

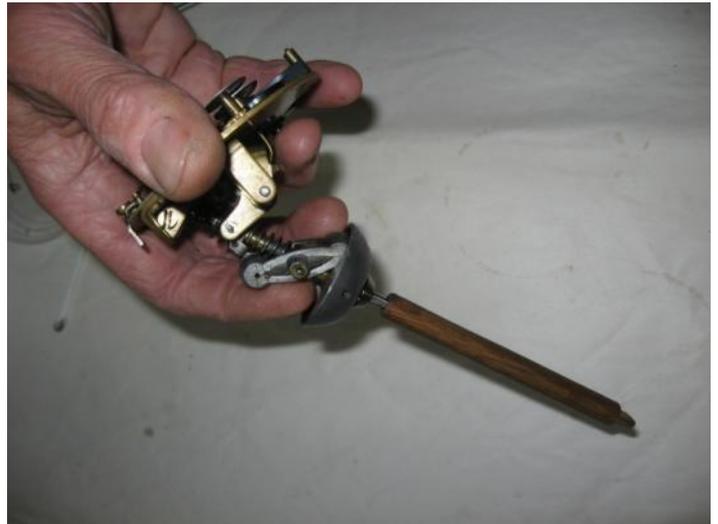
With the spindle engaged in the chassis top bearing use the dowel to help lower the assembly into the instrument body...

Filling the bottom race is fiddly and can be made easier by fashioning a dowel about 4" long that just passes through the lower bearing cup. Drill a hole up the centre

of the dowel of sufficient diameter to insert the bottom end of the drive spindle. Insert the dowel into the lower cup race and pack the balls around it. This stops them being dislodged and falling through the centre and onto the floor (again).

With the spindle engaged in the chassis top bearing use the dowel to help lower the assembly into the instrument body...

Now lift the assembly and turn it the right way up ready to drop into the body. At this point it will be evident this is not going to work and there will be balls all over the bench (again). However if you insert the bottom end of the drive spindle into the axial drilling in the dowel you can lower the assembly of spindle and movement down into the body on the end of the dowel until the bottom cone is nicely seated in the bottom race. Now carefully hold it all together by fitting the two (easily accessible) cheese head 6BA screws to secure the chassis to the body. Now you can relax and breathe again and fit the hidden countersunk screw. Finally adjust the end float with the threaded top cup until there is just no perceptible axial

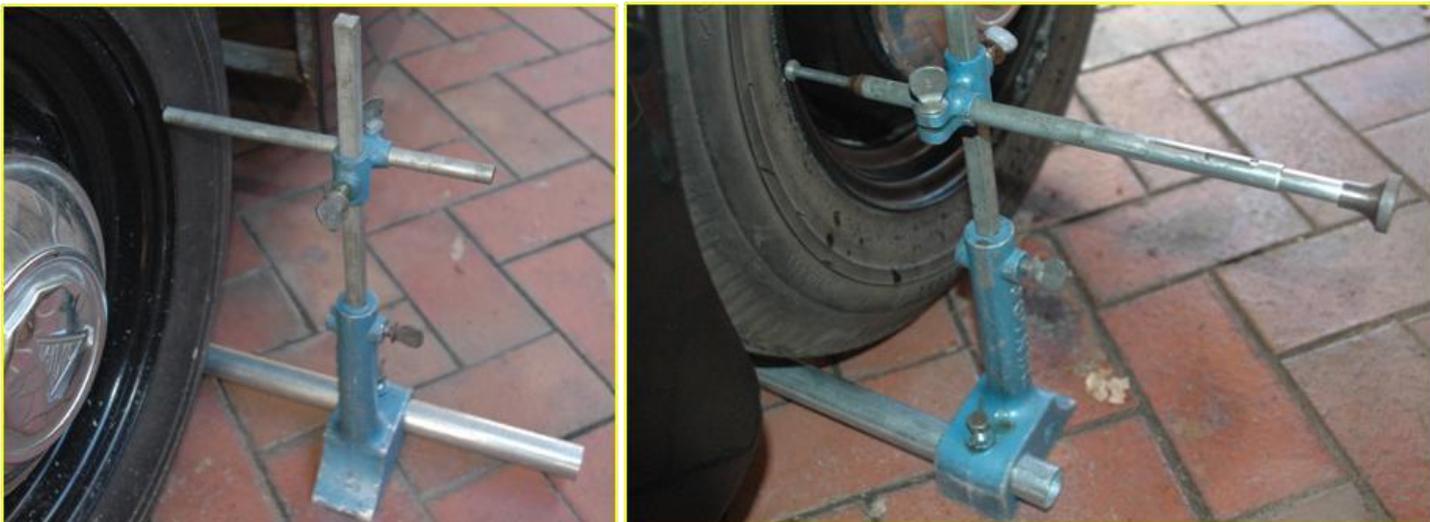
As can be seen in the above photos the centre line of the wheel is the starting point for the measurement. I repeated the process this time without rotating the wheels in order to see if the rims were true and they were. Assuming that all adjustments have been done correctly and everything else is in proper order the steering wheel spokes should be symmetrical in the straight ahead position.

Having made sure that all the gauge finger screws were tight I pulled the spring loaded calibration rod out to its locking position and then tipped the gauge on its side and rolled the car forward half a wheel rotation so that the toe reading

was taken from the same rim positions. This lessened the possibility of out of true rims effecting the reading. The gauge was then pulled through and set up again this time in front of the wheels. With the lever released a reading could be taken and compared with the original. The tie rod was subsequently rotated in order get a zero toe reading, (i.e. the same as the starting point) as I have found zero toe to be quite satisfactory when running cross ply tyres.

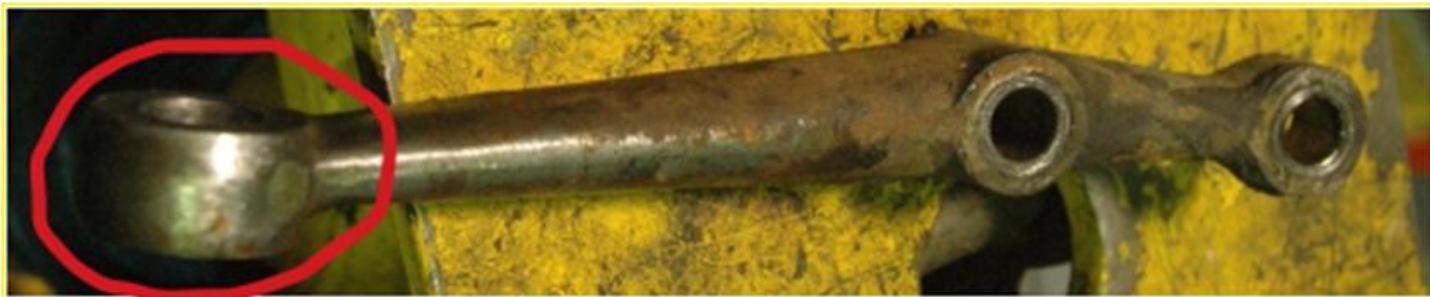
In that earlier article I ended with a comment on regular steering arm inspection (see below) and I feel it is worth mentioning it again for there is not an overly generous amount of metal around where the side tie rod ball joint tapered end fits within each steering arm. If one of these were to fracture due to age related fatigue or other cause, then steering would be lost.
